## INSPECTION & TESTING REPORT

| <b>Inspection Type Performed:</b> Witness failure verification | <b>Inspection Date:</b> 21 & 22 October 2014 |

Witness the maximum load (force) the nail plate can withstand

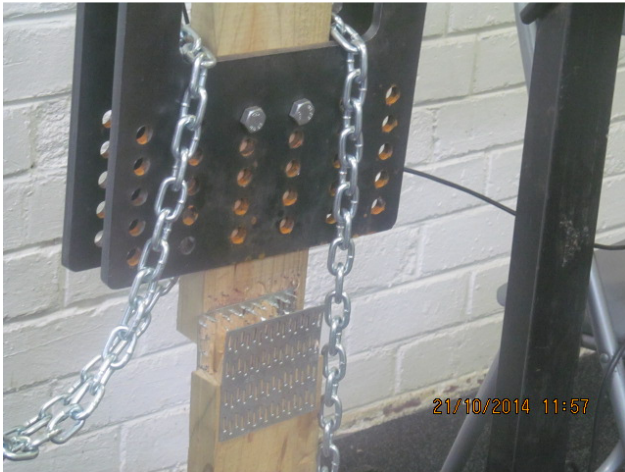
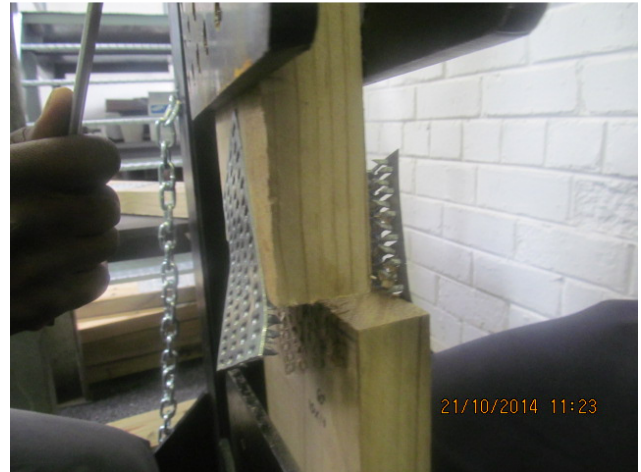
| <b>Overall Inspection Conclusion:</b> | During the various tests, the nail plates did not break apart<br>The nail plates bent or the timber broke off the nail plate |

Tensile strength test failures

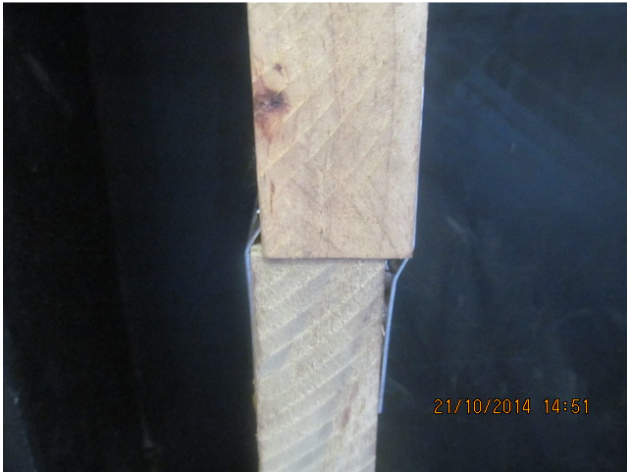
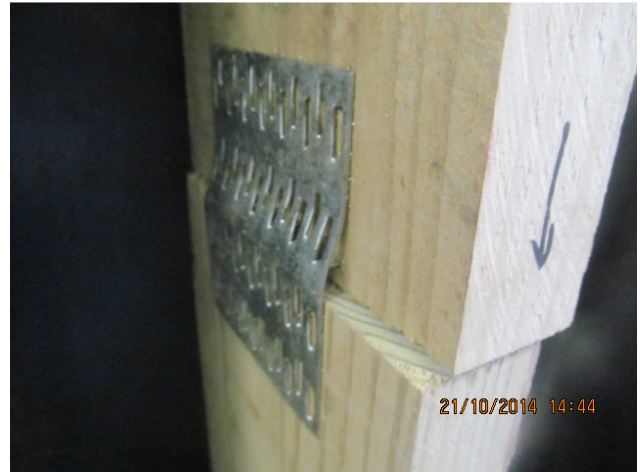
Compression strength test failures

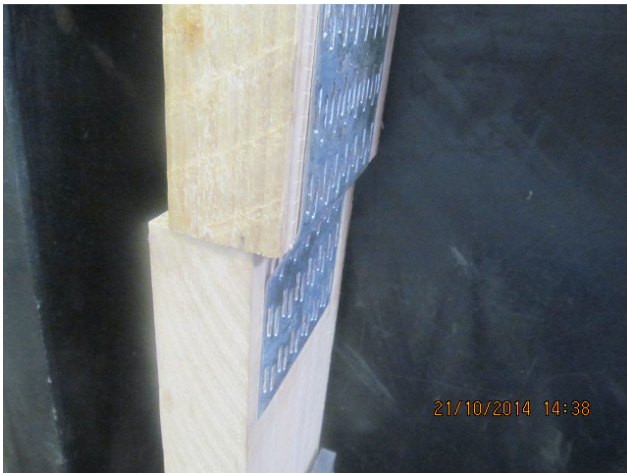
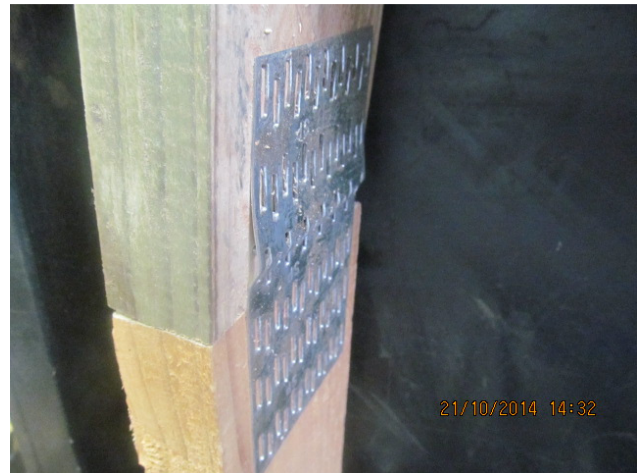
Compression strength test failures

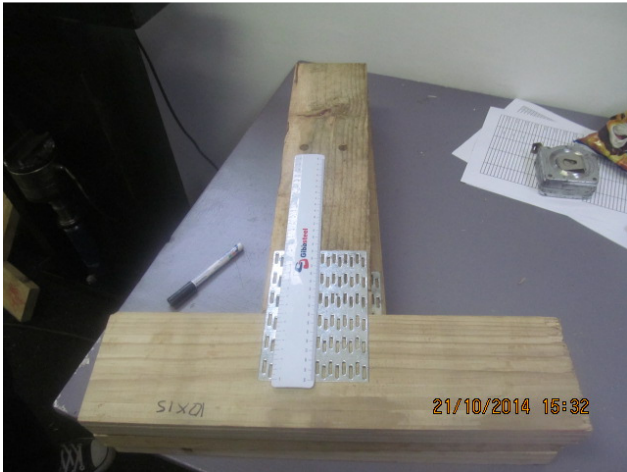
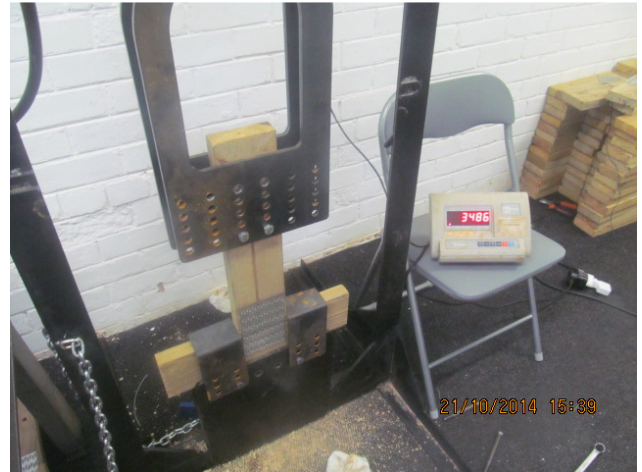
Anchorage perpendicular test failures

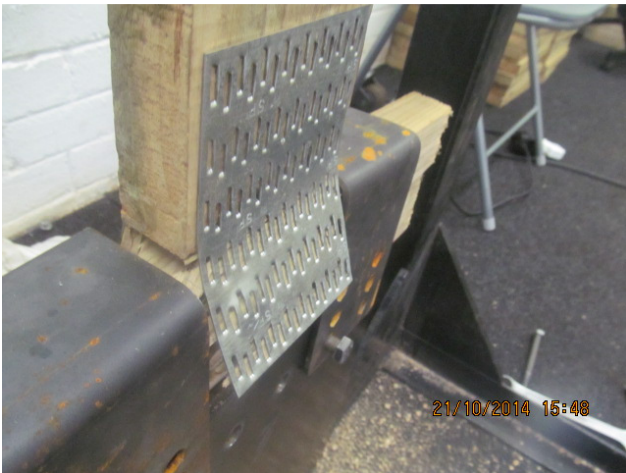
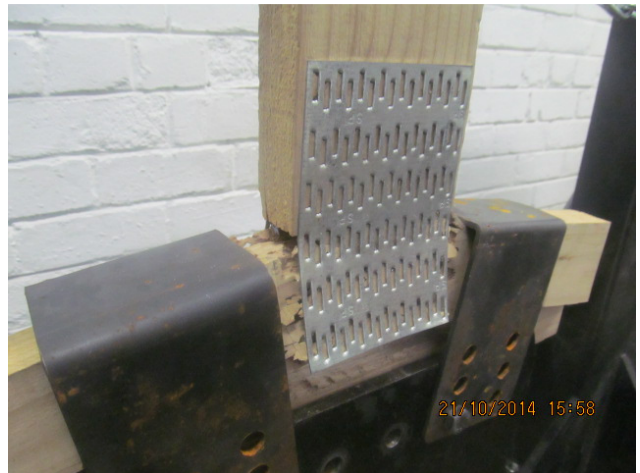
Anchorage perpendicular test failures

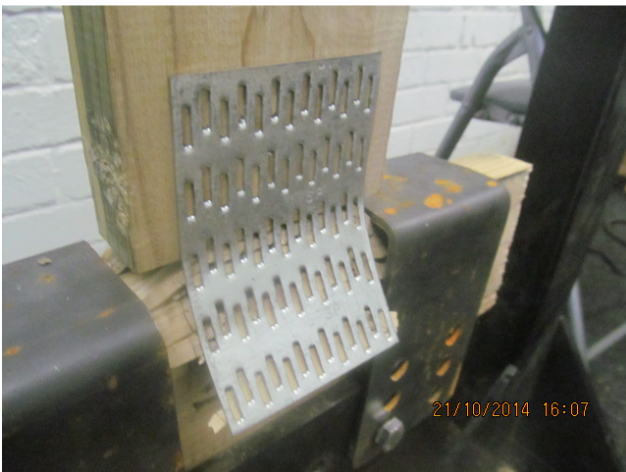
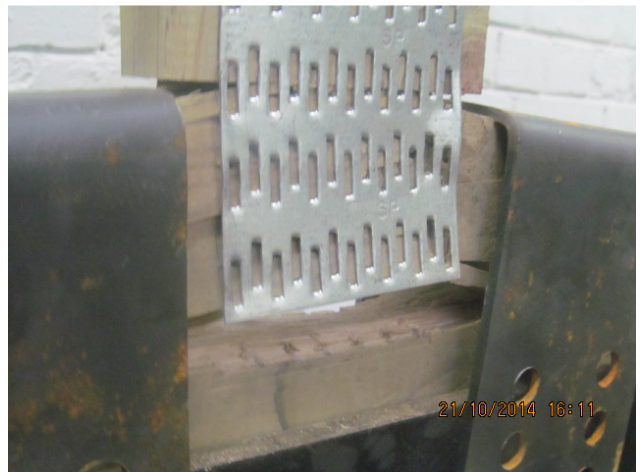
Anchorage perpendicular test failures

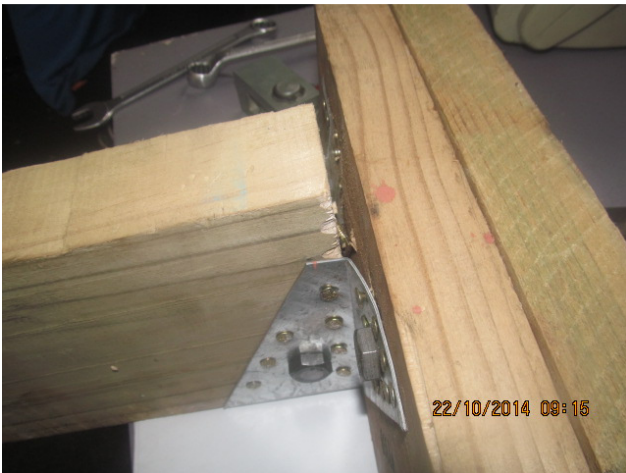
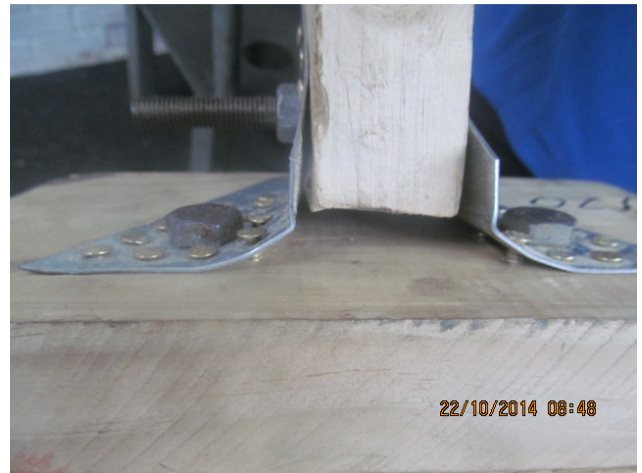
Truss Hanger tests failures

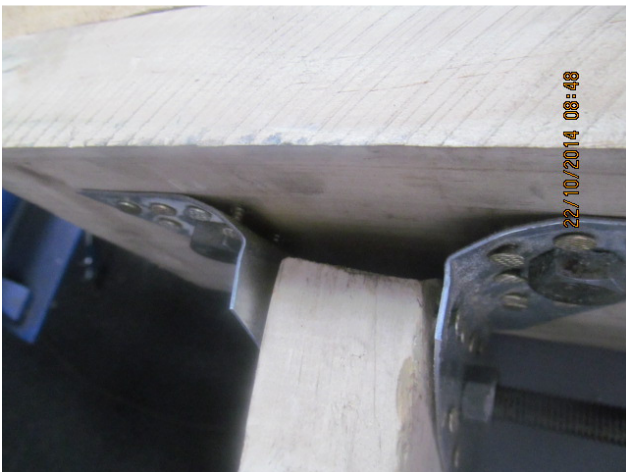
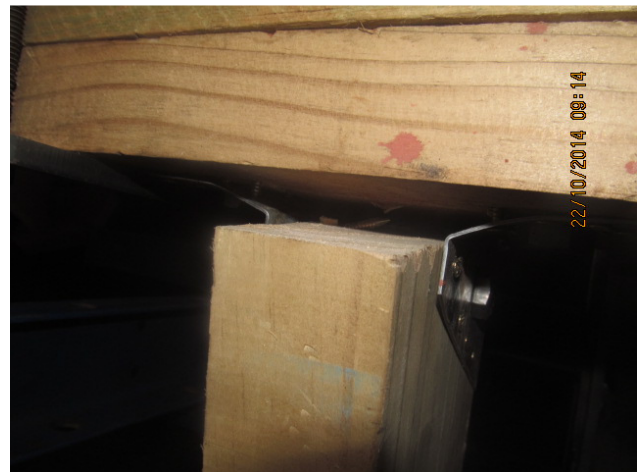
Truss Hanger tests failures

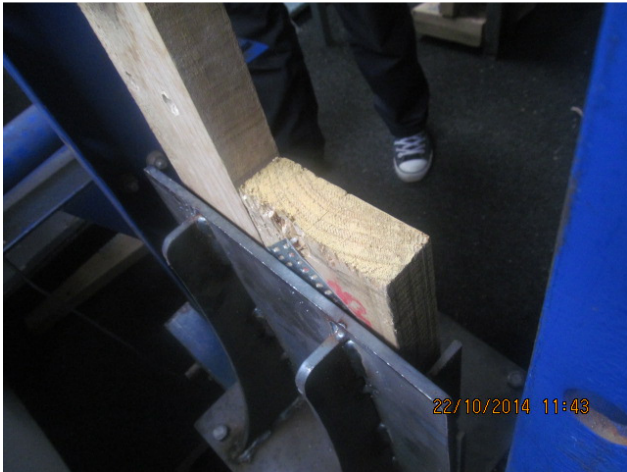
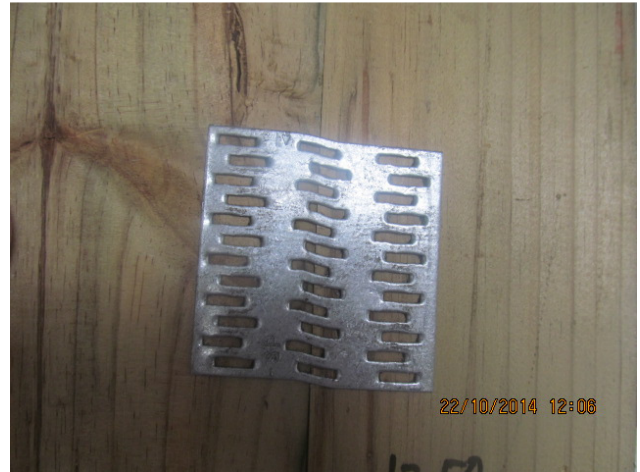
Shear strength test failures

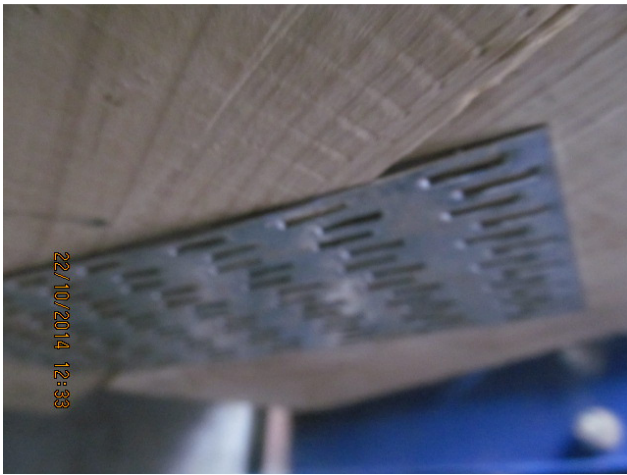
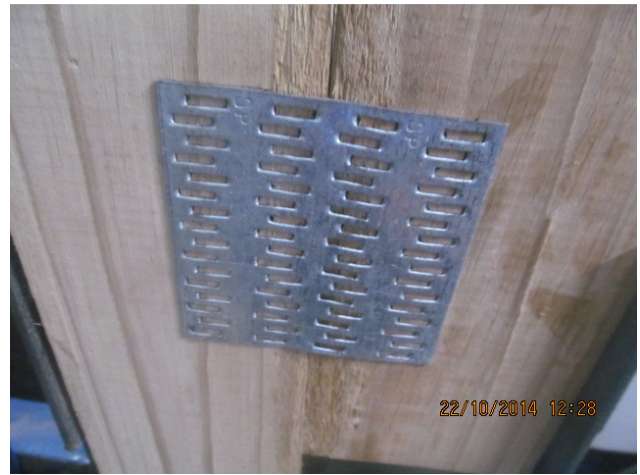
Shear strength test failures
